May 1, 2015

HySecurity Re-Certifies Leeson 1 & 2 HP Single-Phase Electric Motors

Blue Leeson Motors Will Start Showing up in Hydraulic Operators May 2015

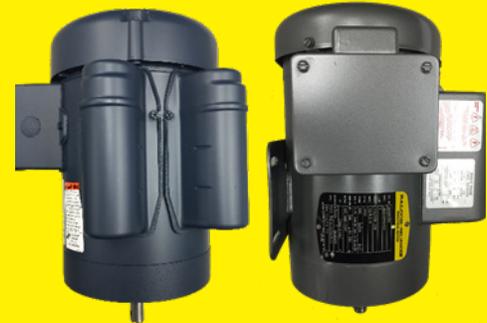
Blue Leeson

Gray Baldor
